**Technical Service
BULLETIN**

**M.I.L. "ON" DTC P0171, P030#, AND/OR
P0133 ENGINE RUNNING LEAN IN
SUBFREEZING AMBIENT
TEMPERATURES**

'00 – '05 Celica (1ZZ-FE)

**ENGINE
EG046-07**

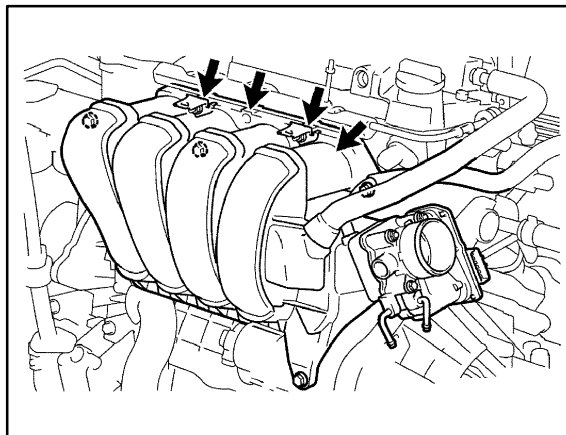
2. Following conventional diagnostic procedure, confirm if there is a leak where the intake manifold and cylinder head meet between each intake runner.

3. Did the short term fuel trim change to a rich reading (negative fuel trim) in step 2?
 - If **YES** — Replace the intake manifold gasket.
 - If **NO** — Check for other vacuum leaks or lean running conditions per the Technical Information System (TIS).
